Case Study - Grouting Abandoned Utilities

Anderson Road and Macleod Trail SW Calgary, Alberta, Canada

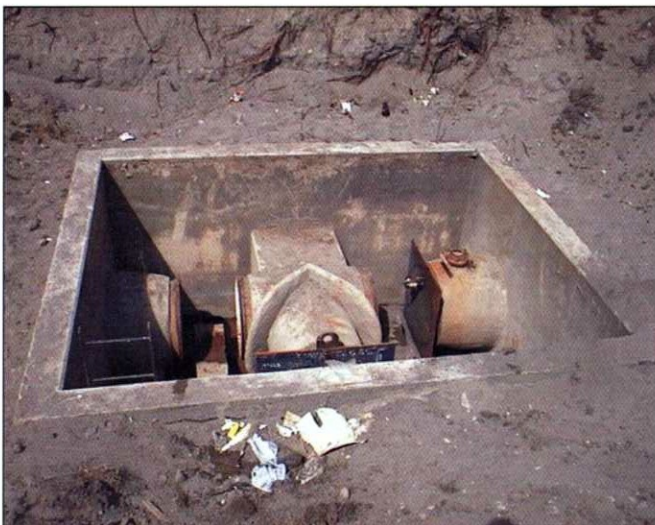
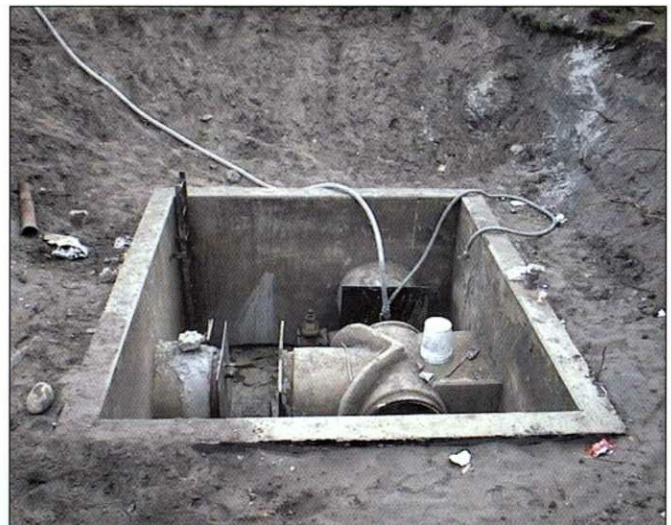
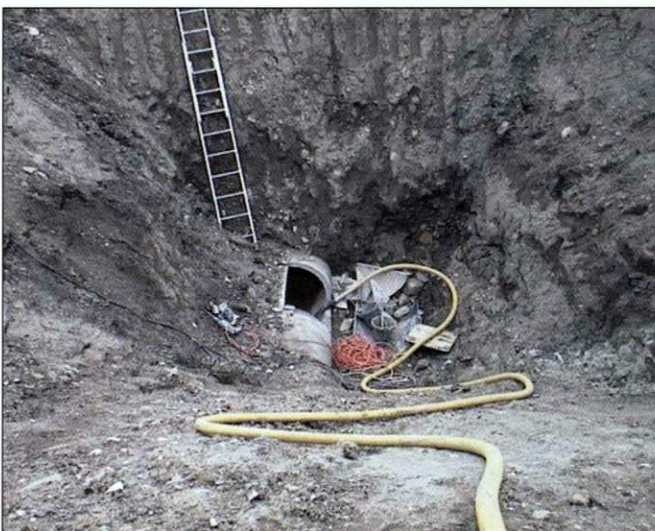
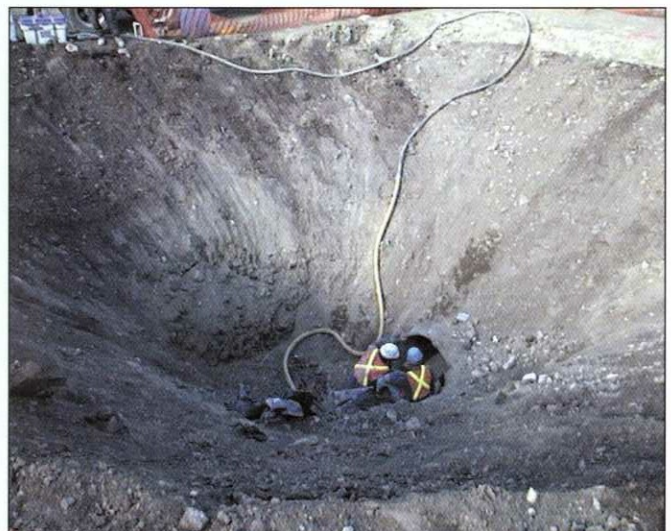
Solution: CEMATRIX CMG-500 grout was used to easily and reliably fill the abandoned water main. Easy to install, light gauge steel bulkheads were placed at either end of the pipe sections to contain the cellular material.
